Walking Tour of Seismic-resistant Design and the 1976 Earthquake Damage to Baroque Buildings in Antigua, Guatemala

Tina M. Niemi, University of Missouri-Kansas City, U.S.A.
Hairo Castellanos, Consejo Nacional para la Protección de Antigua Guatemala
Elizabeth Bell, Antigua Tours, Guatemala

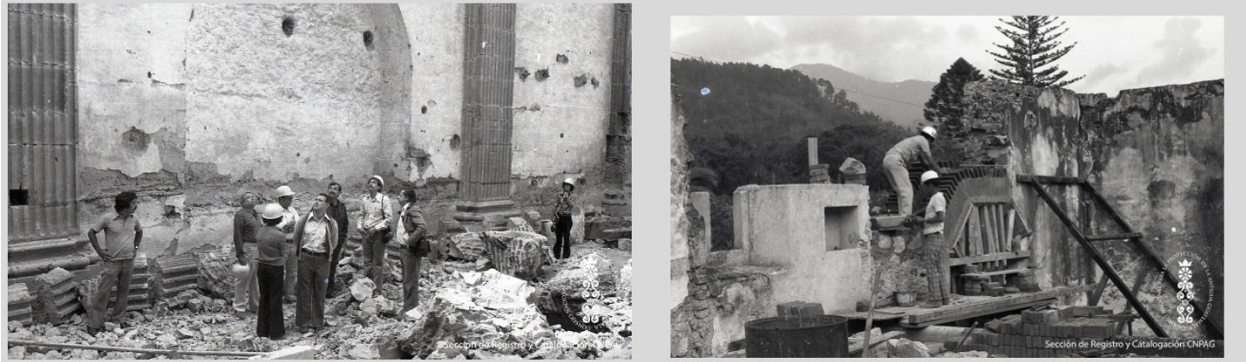
Designed by Architect Diego de Porres, it preserves all the elements of seismic-resistant design, including enormous, wide short columns supporting low arches around the courtyard and exceedingly thick walls with low buttresses on the exterior (Fig. 2). A unique round structure (Tower of Retreat for the Novices), 24 m in diameter, contains 14 small rooms on the upper floor supported by a massive central column in a lower storage room. The Convent sustained some damage in the 1751/1773 earthquakes and was completely abandoned in 1774 when the capital was moved to present-day Guatemala City. In 1850, Capuchinas was sold to a family who dried coffee beans on the second floor. Today, the offices of the National Council for the Protection of Antigua Guatemala (CNPAG) are located in Capuchinas. The 1976 earthquake caused the collapse of a church vault and damage to the exterior walls of the church and convent (Fig. 3)

Figure 3: Damage from the 1976 earthquake and repair to the Convento y Iglesia Capuchinas (Courtesy of CNPAG Sección de Registro y Catalogación).

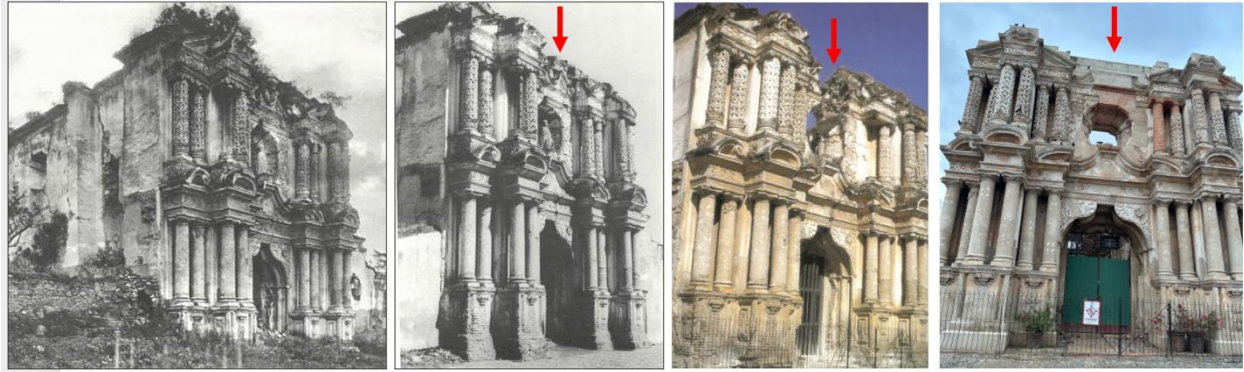
Iglesia Carmen was initially built in 1638 but was severely damaged by earthquakes in the 17th and early 18th centuries and rebuilt twice. The elaborately decorated, ornate church seen today was constructed in 1728. Although the church sustained damage in the July 1773 earthquake, it was not until the December 1773 earthquake that the vaults, dome, and bell tower collapsed. Consolidation work began in the 1990s to help stabilize the church, and the reconstruction efforts are ongoing.

Figure 4: Façade of the Iglesia Carmen from left to right: 1876, pre-1976, post-1976, and 2024. Note the earthquake damage and toppling of both the statue of Our Lady of Carmen and one of the upper columns (Markman, 1966).

CNPAG conservation and reconstruction efforts on the Carmen Church follow traditional building methods, with the exception of the addition of Portland Cement in brickwork. The mortar is a mixture of soil (talpatate), black volcanic river sand, white pumaceous sand, and lime. Analyses of mortar and stucco indicate that a large component of pumice inclusions likely improved the strength and ultimately the longevity of the high-relief ornamentation (Trudell et al., 2025). Stress testing of the building components in situ using a Schmidt Hammer also suggest the composition of the mortar plays a role in the building cohesion.

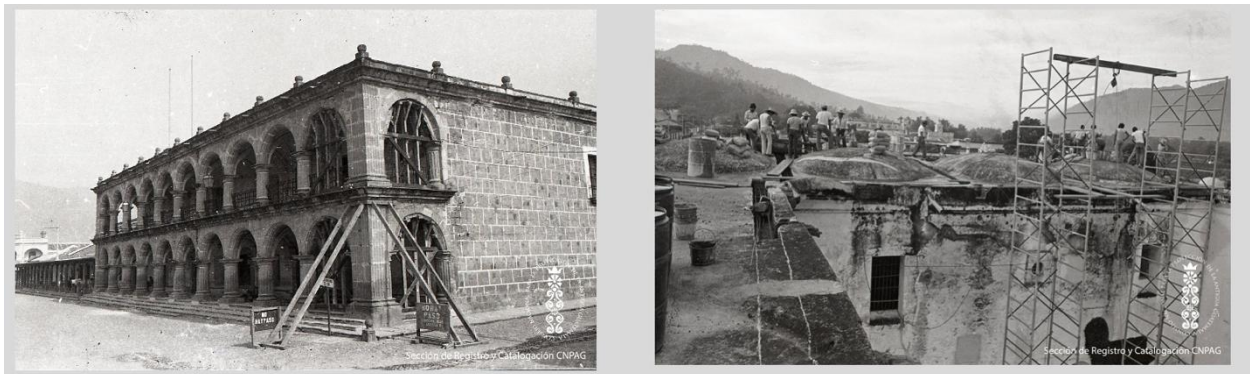
The design of City Hall clearly displays the unique style of earthquake-resistant architecture. The double arcade supports broad arches on wide, short stone columns. The exterior walls are 1.2 m (4 ft) thick and veneered with cut stone. The structure survived earthquakes in the 19th and 20th centuries. In 1976, the earthquake caused damage to part of the southeast arcade and roof domes (Fig. 5).

Figure 5: Stone columns and arches of City Hall showing damage to the southeast archway and roof domes from the 1976 earthquake (Photos courtesy of CNPAG Sección de Registro y Catalogación).

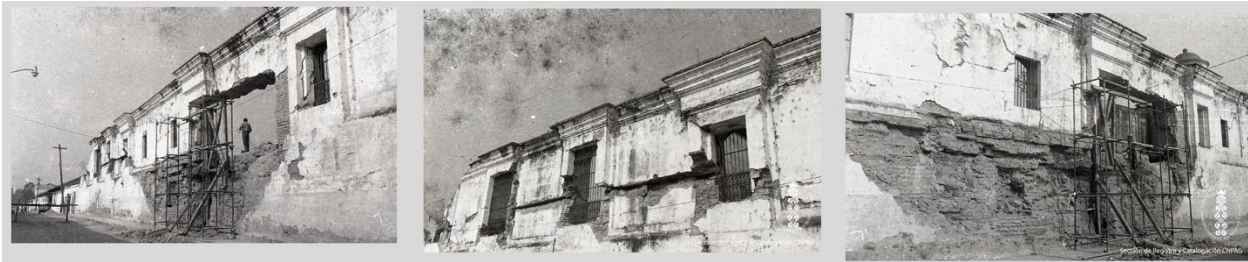
The early wooden structures at the site were badly damaged in the 1717 and 1751 earthquakes. By 1764, the construction of the new palace with its massive stone columns and stone veneer was completed. The structure was only slightly damaged in the earthquakes of 1773. Most of the ornamentation and elaborate fixtures of the Palacio were removed and sent to the new capital in Guatemala City. An attempt to transport the columns failed as they were too heavy for mules to pull. The façade was rebuilt in 1890. The 1976 earthquake caused extensive damage to the east wall of the Palace (Fig. 6).

Figure 6: East wall of the Palace of the Captains General showing collapse and shearing of the exterior east wall (Photos courtesy of CNPAG Sección de Registro y Catalogación).

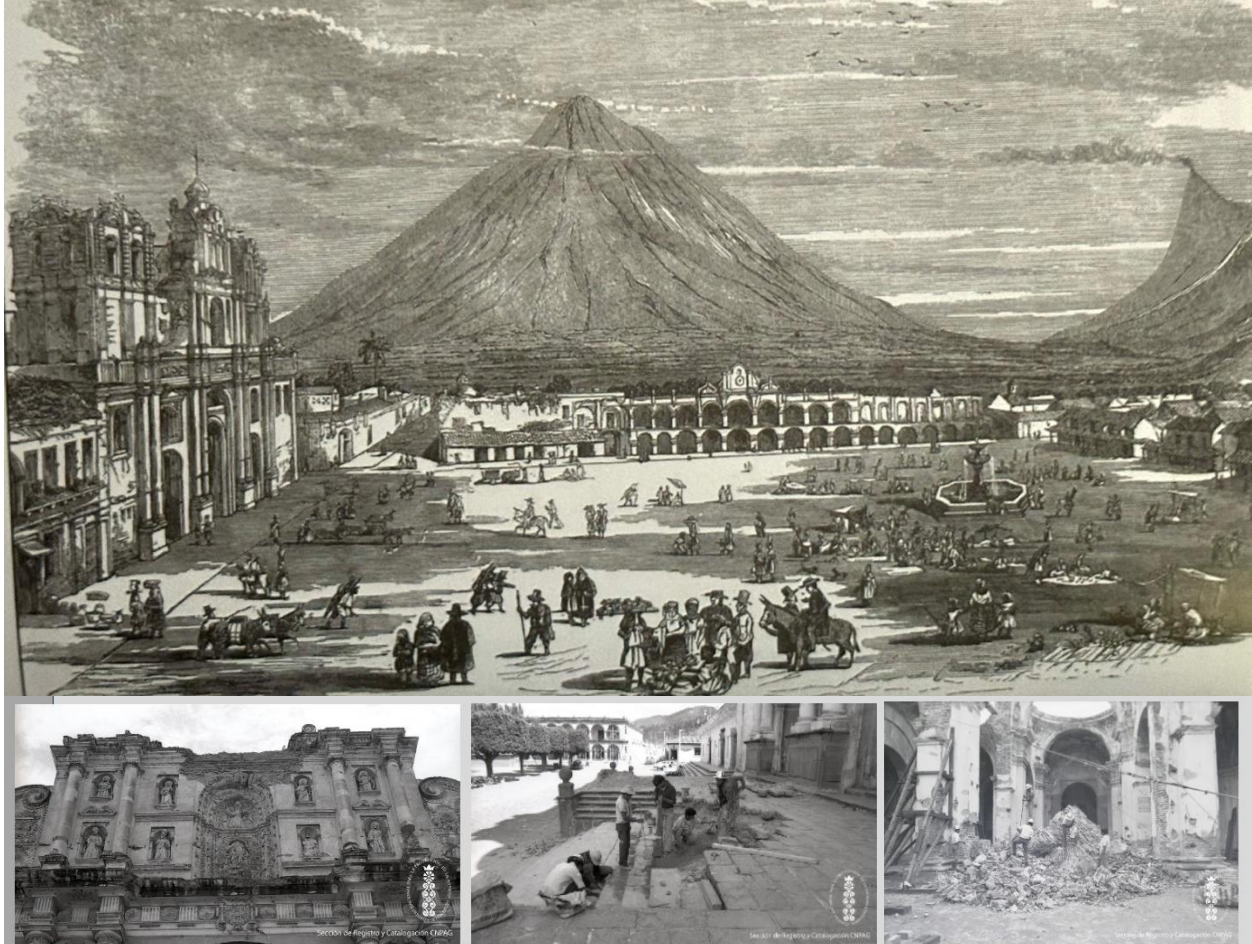
The 1856 engraving of the Plaza, Palace of the Captains General, and Cathedral shows the bell tower to the north of the church façade (Fig. 7). The 1976 earthquake caused the collapse of the central façade of the church, which fell and damaged the stairway. Additional damage occurred inside the cathedral ruins.

Figure 7: Top: An illustration of the Central Plaza published in *The Illustrated London News* on August 3, 1856 (Bell, 2010, p. 18). Note the bell tower to the north of the façade of the cathedral. Bottom Row: Photographs showing the collapse of the central portion of the cathedral façade, damage to the steps below, and within the ruins. (Photos courtesy of CNPAG Sección de Registro y Catalogación).

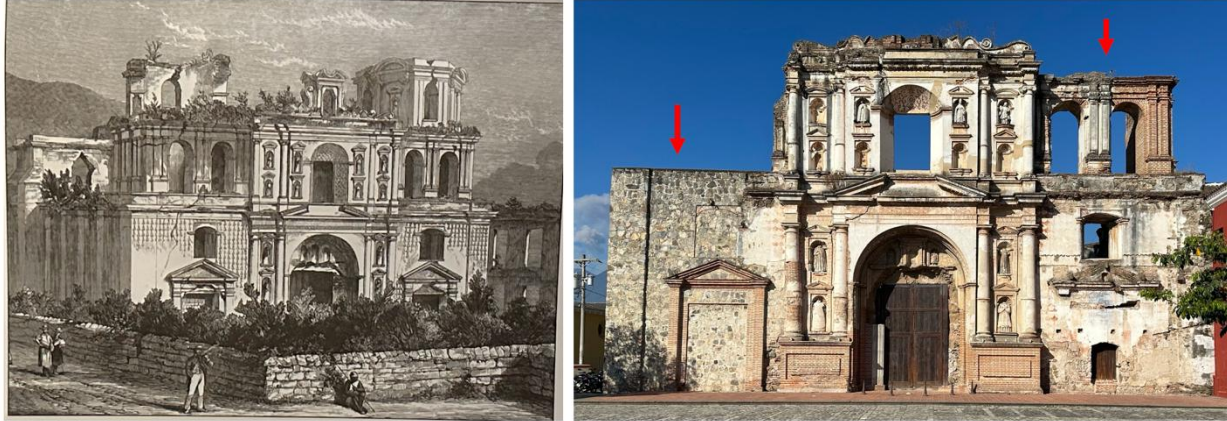
Figure 8: Left: Illustration of *Compañía Jesús* from *The Illustrated London News*, March 12, 1859. (Bell, 2010, p. 79). Right: Photograph of the façade of the church of *Compañía Jesús* in 2025. The red arrows point to portions of the structure that collapsed and have been reconstructed.

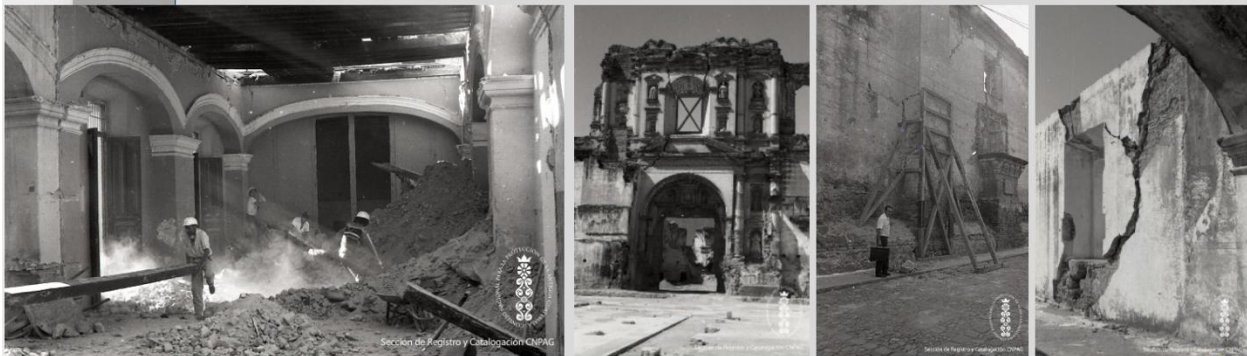
Iglesia y Convento de la Compañía de Jesús was established by the Jesuit fathers upon their arrival in Guatemala in 1607. An early thatched church was replaced by a new church in the 17th century. This structure was destroyed in the 1695 earthquake and replaced by a new church. The church withstood the 1717 earthquake but was severely damaged in the 1751 earthquake, as historical documents indicate the Jesuits received funds for repairs. By Spanish Royal decree in 1767, the Jesuits were expelled from Guatemala under armed guard. In 1865, a textile factory occupied the site, and in 1912, the Public Market (*Mercado*) relocated to the monastery from the plaza. The monument sustained significant damage in the 1976 earthquake, and the mercado was moved to its current location. Conservation by CPNAG and after 1990, by Cooperación Técnica Española, has led to the current renovation of the entire monastic complex extending across the entire city block.

Figure 9: Photographs showing the damage to the church and convent of *Compañía Jesús* after the 1976 earthquake (Photos courtesy of CNPAG Sección de Registro y Catalogación).

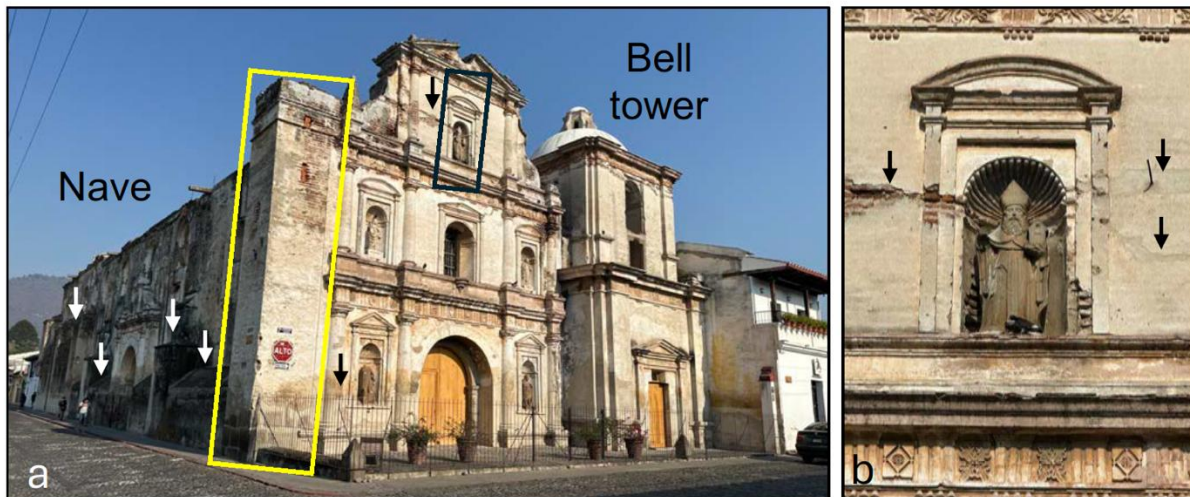
Three building phases can be seen in the interior, where windows and arches are filled, and additional walls abut each other. The later phases have thicker mortar (>5 cm) within the brick arches, which may have weakened the structural integrity. The southwest exterior corner tower, which is wider at its base compared to the top, and the 2-m-thick southern wall support the load of the dome over the nave of the church. Additional buttresses and supporting towers were added to the southern wall. The northeast corner is supported by the bell tower, which contains its original dome, cupola, and portions of wooden floor joists and bell supports. The dome of the nave was intact until the 1917 Guatemala earthquake, when it collapsed. The 1976 earthquake caused the upper story of the choir to collapse.

Figure 10: Oblique view of the front (east) façade and south wall of the Church of San Agustín and bell tower showing antiseismic structural elements and earthquake damage. a) The white arrows point to exterior buttress walls at the base of the south wall of the church. The yellow box outlines the southeast structural corner tower. b) Statue of San Agustín holding a church located in the upper central niche of the church façade. Note the horizontal cracks marked with arrows that cross laterally through the niche and bifurcate into cracks on the north side, demonstrating clear earthquake damage.
