Walking Tour of Seismic-resistant Design and the 1976 Earthquake Damage to Baroque Buildings in Antigua, Guatemala

Tina M. Niemi, University of Missouri-Kansas City, U.S.A.
Hairo Castellanos, Consejo Nacional para la Protección de Antigua Guatemala
Elizabeth Bell, Antigua Tours, Guatemala

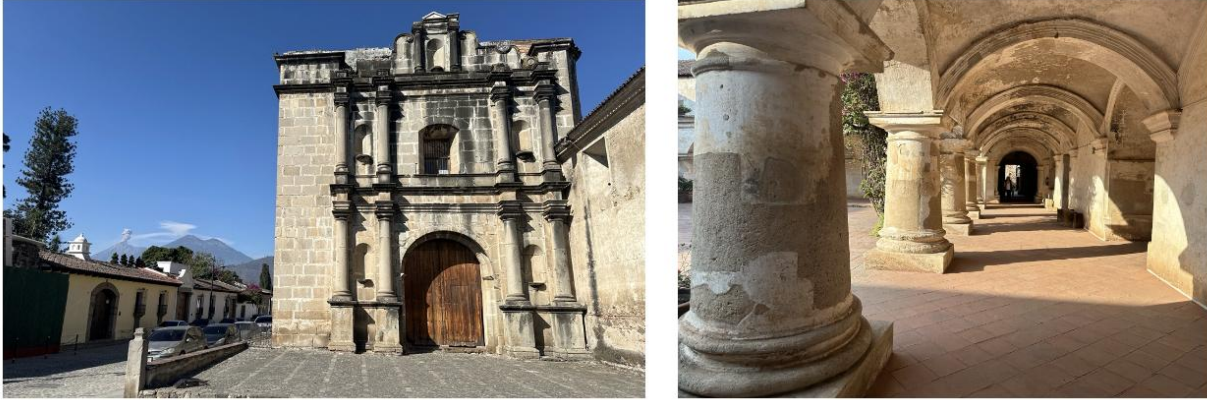
Designed by Architect Diego de Porres, it preserves all the elements of seismic-resistant design, including enormous, wide short columns supporting low arches around the courtyard and exceedingly thick walls with low buttresses on the exterior (Fig. 2). A unique round structure (Tower of Retreat for the Novices), 24 m in diameter, contains 14 small rooms on the upper floor supported by a massive central column in a lower storage room. The Convent sustained some damage in the 1751/1773 earthquakes and was completely abandoned in 1774 when the capital was moved to present-day Guatemala City. In 1850, Capuchinas was sold to a family who dried coffee beans on the second floor. Today, the offices of the National Council for the Protection of Antigua Guatemala (CNPAG) are located in Capuchinas. The 1976 earthquake caused the collapse of a church vault and damage to the exterior walls of the church and convent (Fig. 3)

Figure 2: Left: Two asymmetrical towers frame the simple, unornamented façade of the Iglesia Capuchina. Note the uncommon use of stone veneer on the exterior (Markham, 1961). Vulcan de Fuego is seen erupting in the background. Right: Stout columns of the cloister courtyard.
